# PARTS & SERVICE NEWS

REF NO.	AT02042
DATE	Apr. 5, 2002

**SUBJECT:** INSTALLATION PROCEDURE FOR BOLT OF DIFFERENTIAL COUPLING ON WA1200-3/800-1, 3/900-1

**PURPOSE:** To introduce field reassembly procedure for the end coupling bolt of the input shaft of the axle on WA1200-3, WA800-1, WA800-3, WA900-1 and WA900-3 wheel loaders

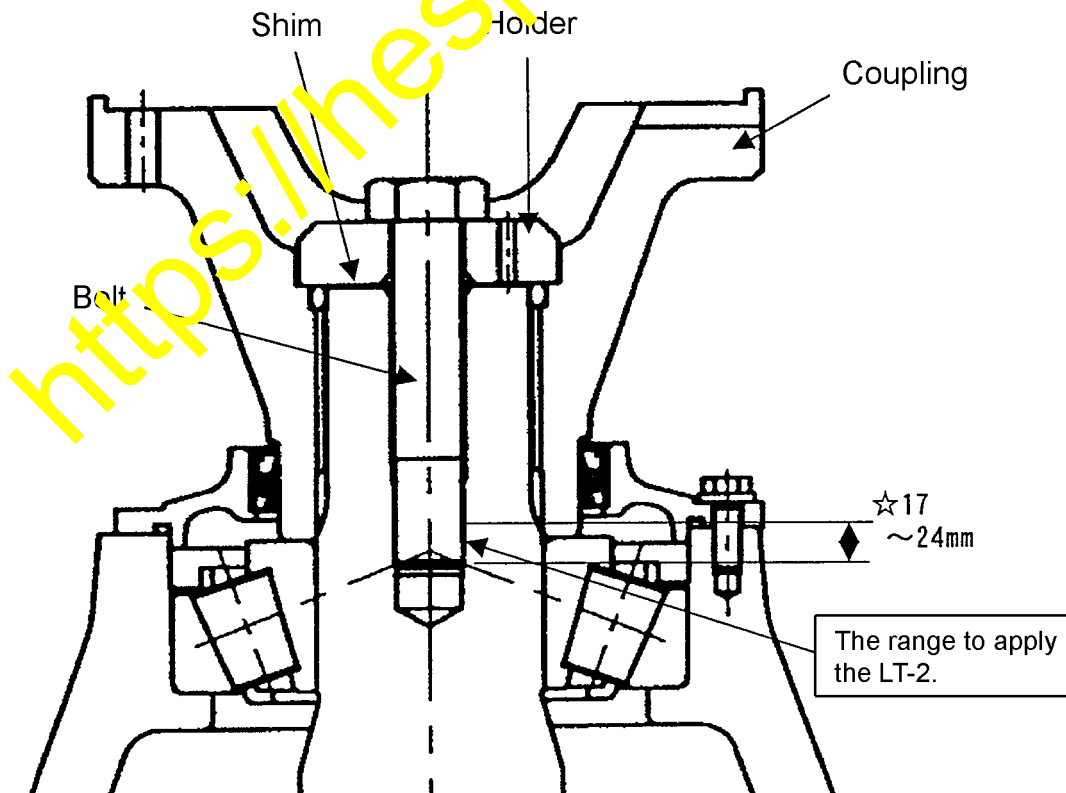
(2) Apply LT-2 to the range marked ☆ being indicated in the drawing below at the tip end of the bolt. Regarding the applying quantity of the LT-2, just apply for a turn of the screw paying attention not to let the LT-2 flow out from the screw section by excessive application.

(1) Thoroughly clean to remove the LT-2 adhered to the female screw surface.

(3) Especially, when carrying out this re-assembly work with the axle being installed to the machine body, since there is a possibility that the shim may be turned together with the bolt to be damaged, be sure to hold the shim and the holder when tightening the bolt and tighten the bolt until the holder becomes immovable. In the meantime, use a new bolt. (Part No. of the bolt: 562-22-11950)

(4) Tighten the bolt at the specified tightening torque.

Tightening torque: 2,450 - 3,040 Nm {250 - 310 kgm}

Be sure to receive the reaction force of the power wrench at the side face of the coupling. (If the reaction force is received at other sections, proper tightening torque cannot be obtained because of the influence of the twists occurring inside the axle.)
